**Quinte Source Protection Area
Updated Conditions Report**

Quinte Source Protection Area Assessment Report

April 25, 2021

Prepared by Mark Boone, P.Ge

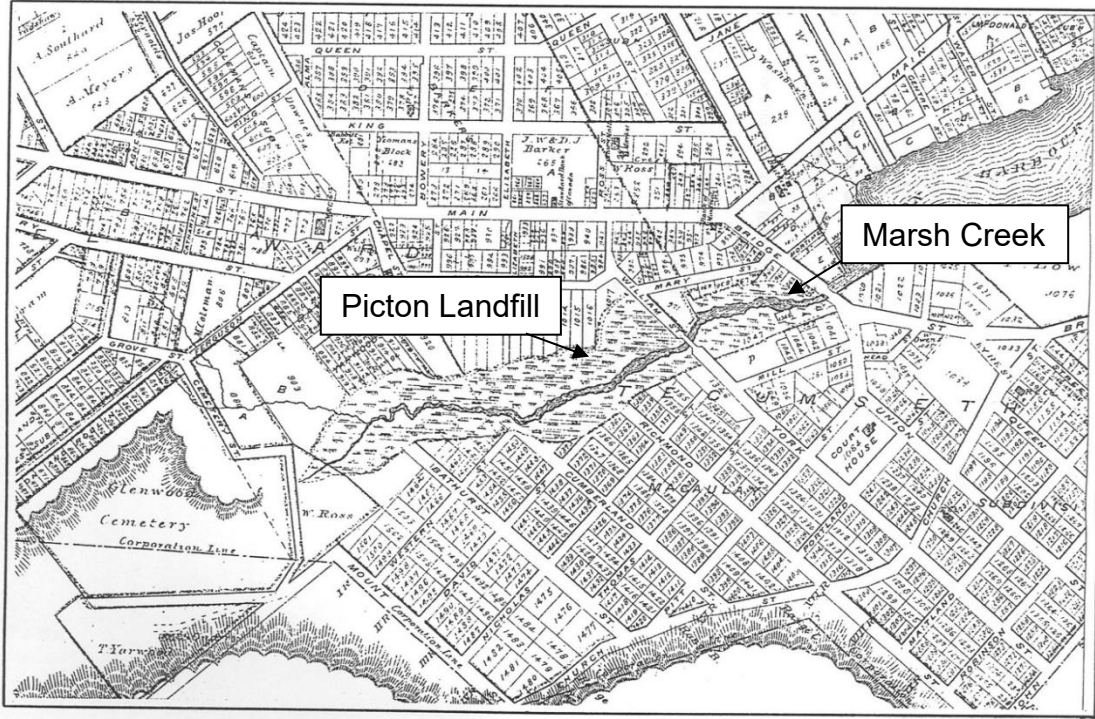
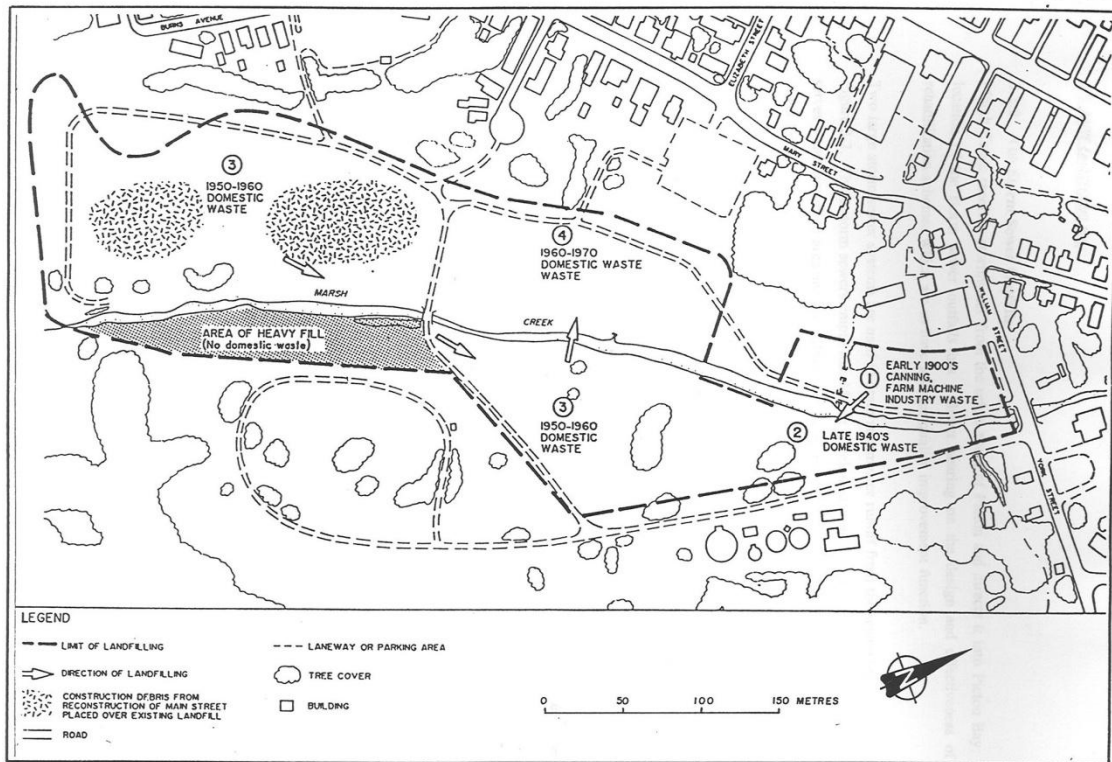
Figure 1: Town of Picton Landfill Site

It was reported that landfill operations was recommended to maintain a 30 metre separation from Marsh Creek. However this recommendation did not appear to be followed (Water & Earth Science Associates, 1989). Water quality monitoring of the creek by the Ministry of the Environment in 1971 and 1979 found the landfill to be impacting on the creek with some parameters identified at higher levels in 1977 than in 1971.

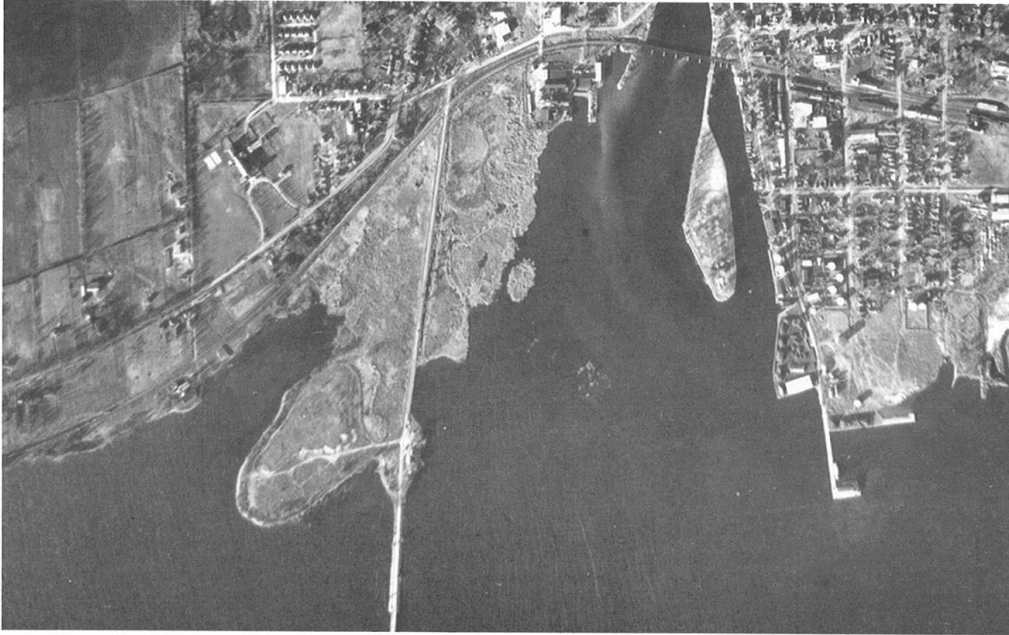
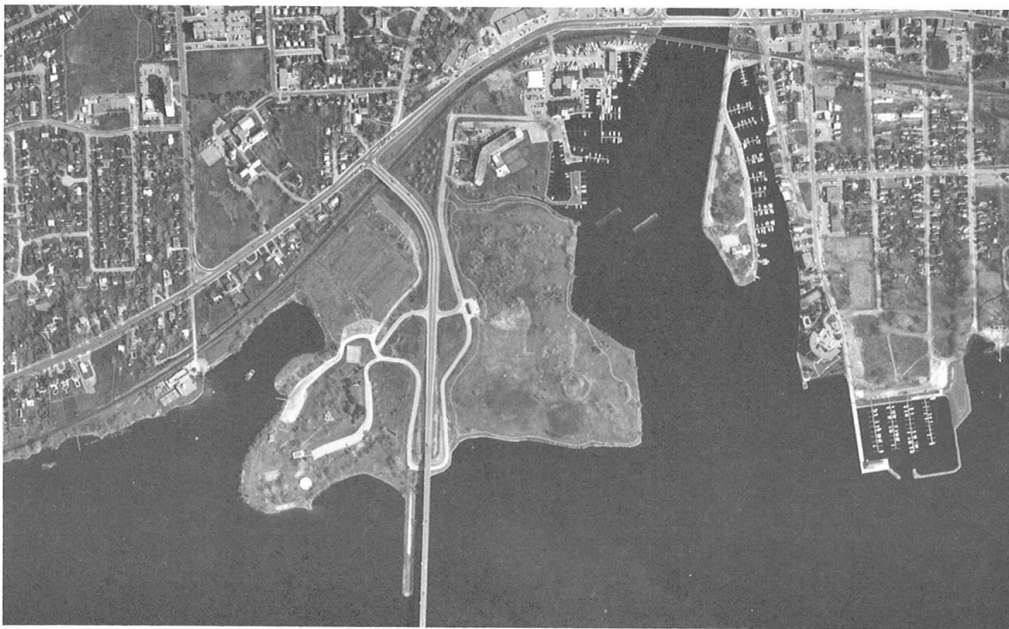
Figure 2: Zwicks Island Landfill Before & After Filling

parameters indicative of landfill leachate. As a result it was found that groundwater flows radially outward from the site towards the Bay of Quinte. Analysis of samples of groundwater found the site to be impacted by landfill leachate, however the overall strength of the leachate was thought to be low.

This low strength was attributed to how the waste was deposited (filling of the Bay) with significant flushing of contaminants and dilution. Parameters that were detected in the groundwater included Benzene, Toluene, Trichloroethane and some pesticides such as Aldrin. Analysis of surface water samples found discharge of leachate to ditches on the site, however the water quality in the Bay was found to not be significantly poorer than water farther off shore. Regardless it was reported that there is continual loading of relatively low strength landfill leachate to the Bay. Continued monitoring was recommended.

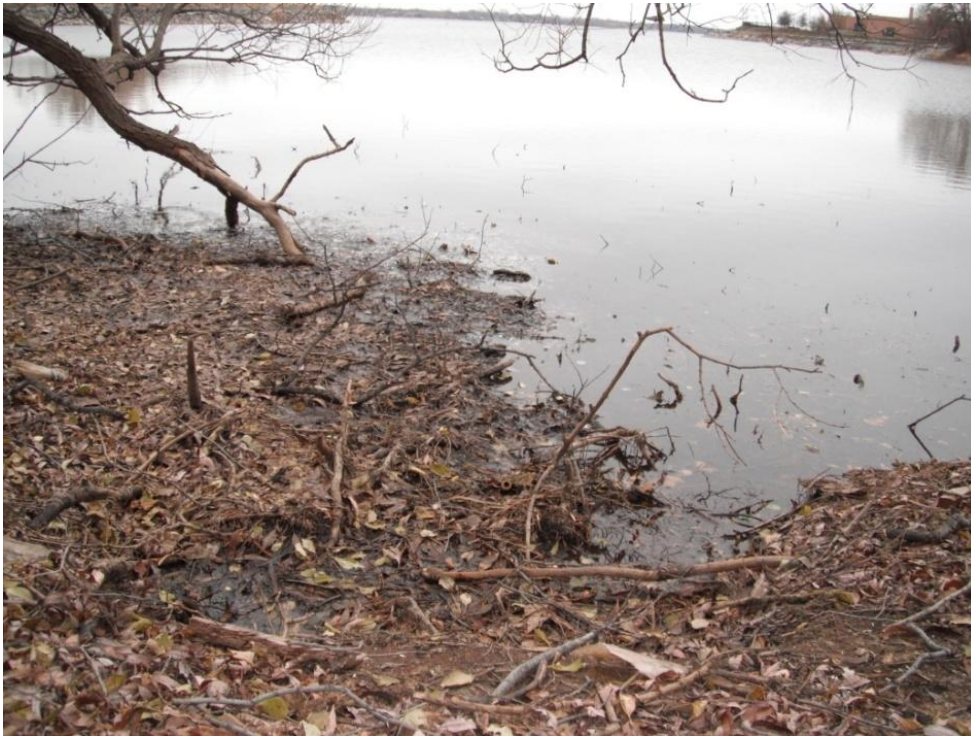
Figure 3: Seep from Zwicks Island Landfill

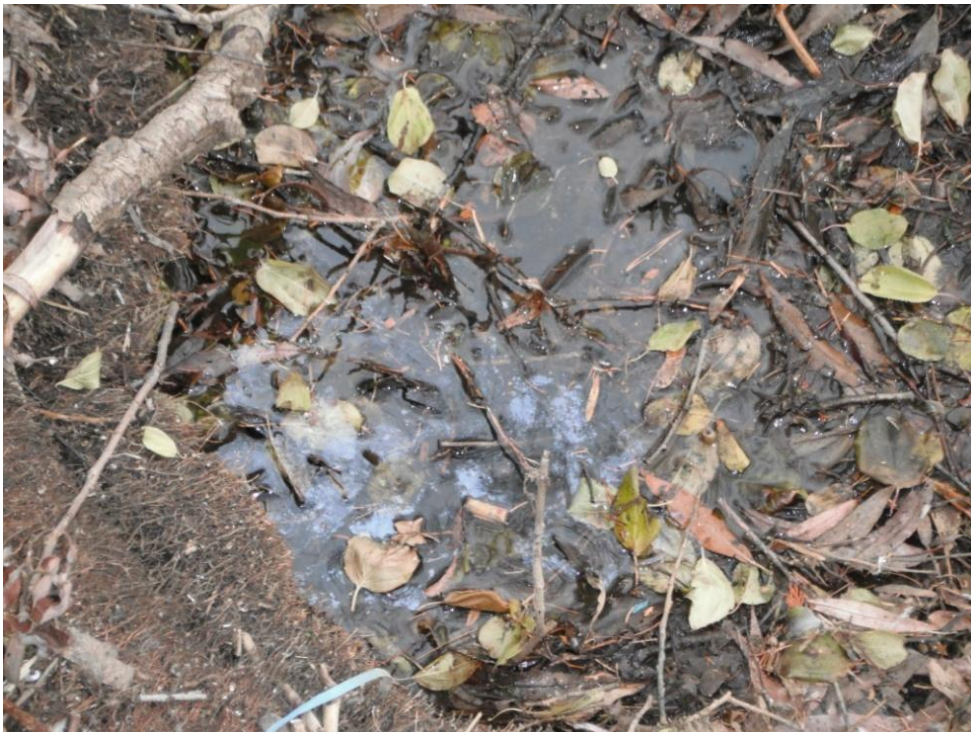
Figure 4: Surface of Seep at Zwicks Island Landfill
