**Quinte Source Protection Region
Updated Conditions Report**

**Submitted to the Source Protection Committee
as part of the
Updated Assessment Report**

April 25, 2019

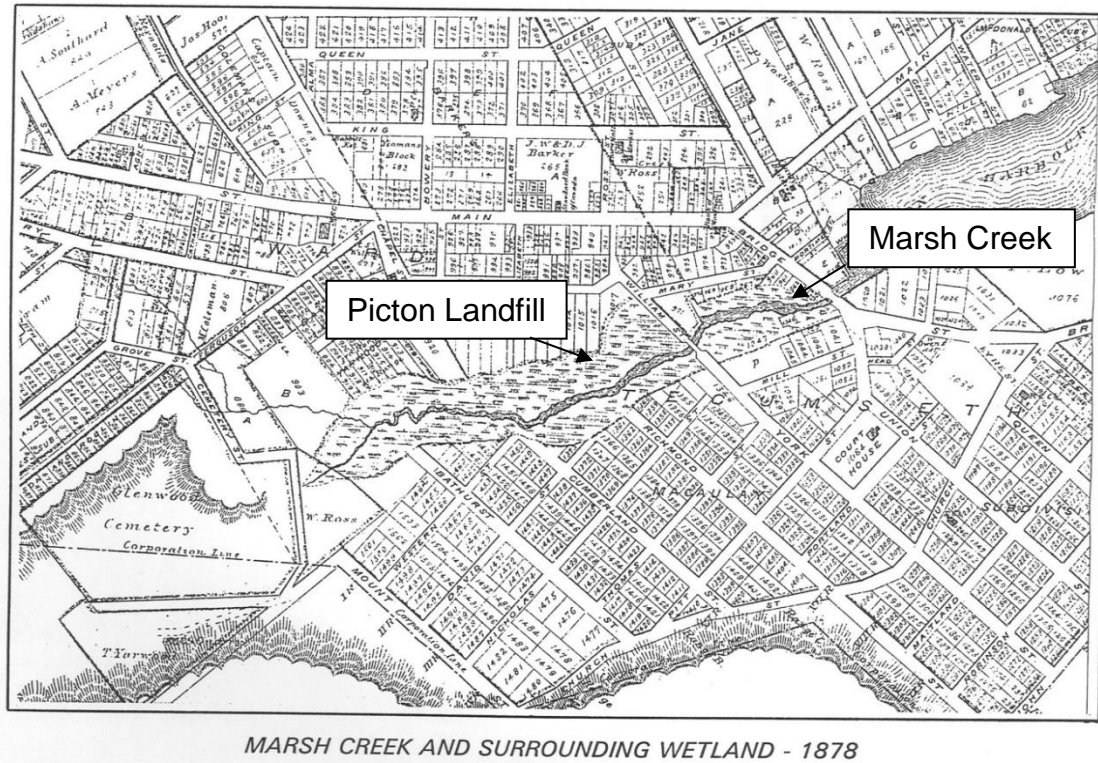
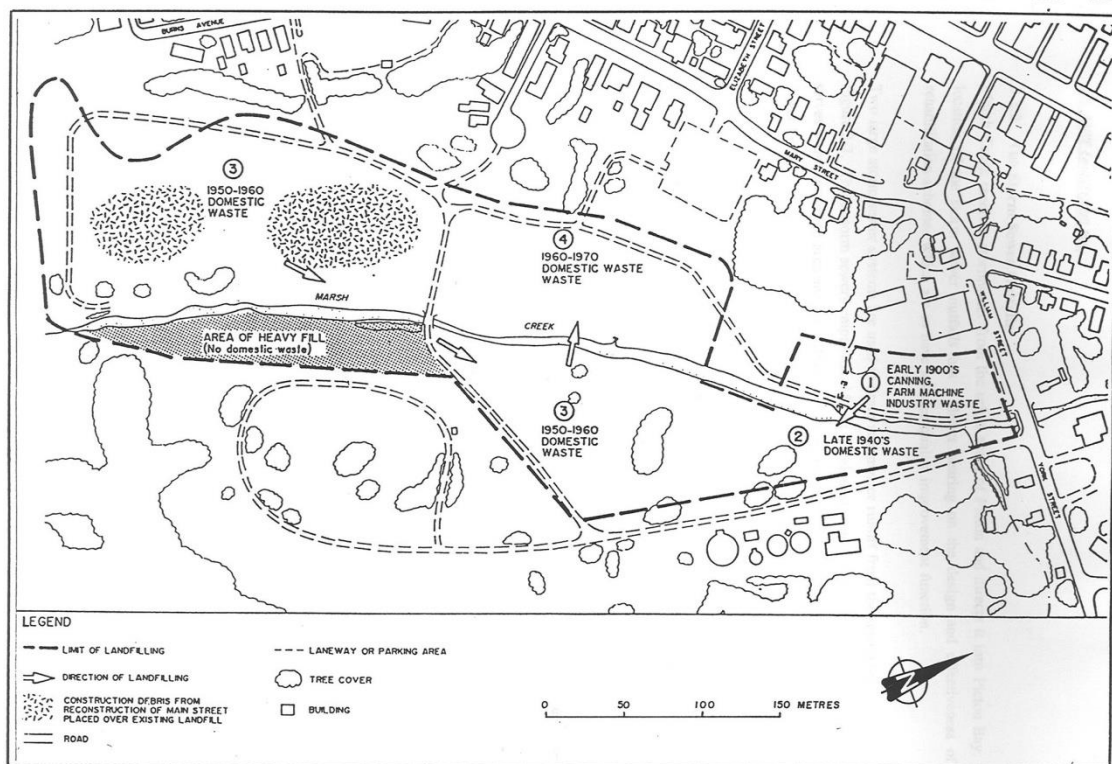
Figure 1: Town of Picton Landfill Site

It was reported that landfill operations was recommended to maintain a 30 metre separation from Marsh Creek. However this recommendation did not appear to be followed (Water & Earth Science Associates, 1989). Water quality monitoring of the creek by the Ministry of the Environment in 1971 and 1979 found the landfill to be impacting on the creek with some parameters identified at higher levels in 1977 than in 1971.

Monitoring in the creek by Water & Earth Science Associates in 1988 indicated an improvement of quality over sampling completed in 1977. This monitoring included sites up and down stream of the sewage treatment plant discharge to allow assessment of water quality parameters potentially originating from the sewage plant as opposed to the landfill site. As a result parameters were detected that were indicative of leachate from the landfill. This included low levels of both inorganic and volatile organic compounds with levels increasing as the creek traverses through the site. The levels of these contaminants were reported as being below the drinking water standards at that time and it was speculated that the impacts of this leachate would likely be immeasurable in Picton Bay due to biodegradation and dilution. The overall degradation of water quality was speculated as not being severe, however an oily film and scum were reported to exist on the creek during periods of low flow (WESA, 1989).

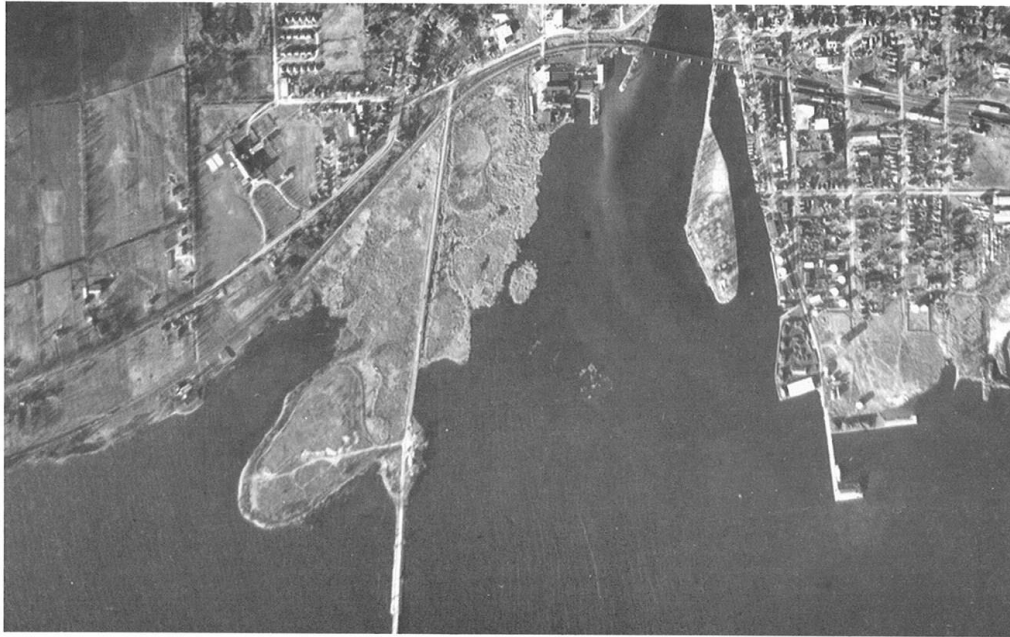
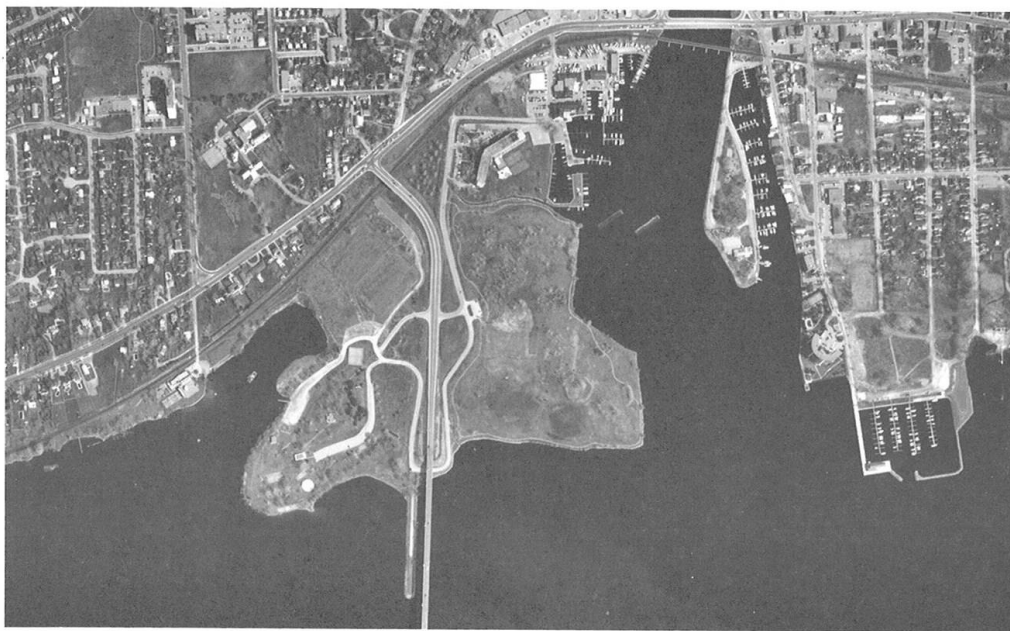
Figure 2: Zwicks Island Landfill Before & After Filling

parameters indicative of landfill leachate. As a result it was found that groundwater flows radially outward from the site towards the Bay of Quinte. Analysis of samples of groundwater found the site to be impacted by landfill leachate, however the overall strength of the leachate was thought to be low.

This low strength was attributed to how the waste was deposited (filling of the Bay) with significant flushing of contaminants and dilution. Parameters that were detected in the groundwater included Benzene, Toluene, Trichloroethane and some pesticides such as Aldrin. Analysis of surface water samples found discharge of leachate to ditches on the site, however the water quality in the Bay was found to not be significantly poorer than water farther off shore. Regardless it was reported that there is continual loading of relatively low strength landfill leachate to the Bay. Continued monitoring was recommended.
